Case report

A case of twitching on the pacemaker pocket

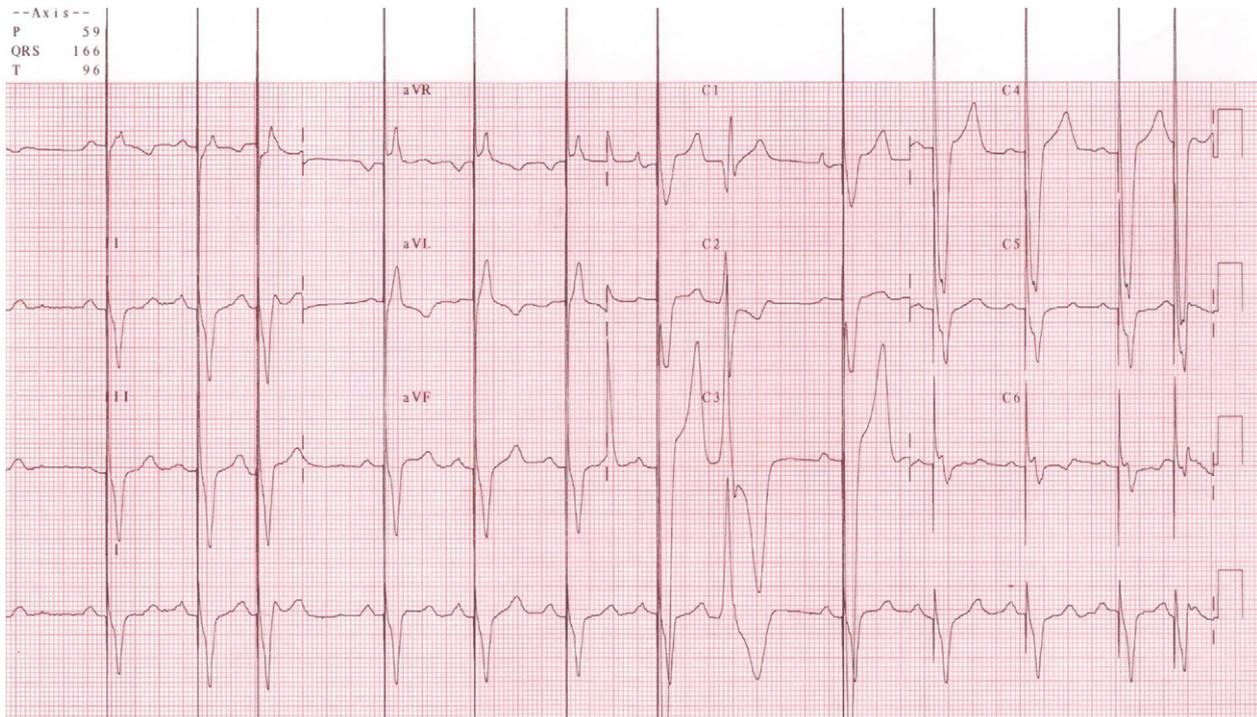
Fig. 1. Electrocardiogram revealed exaggerated pacemaker spikes in all leads and left bundle branch block with sinus p wave.

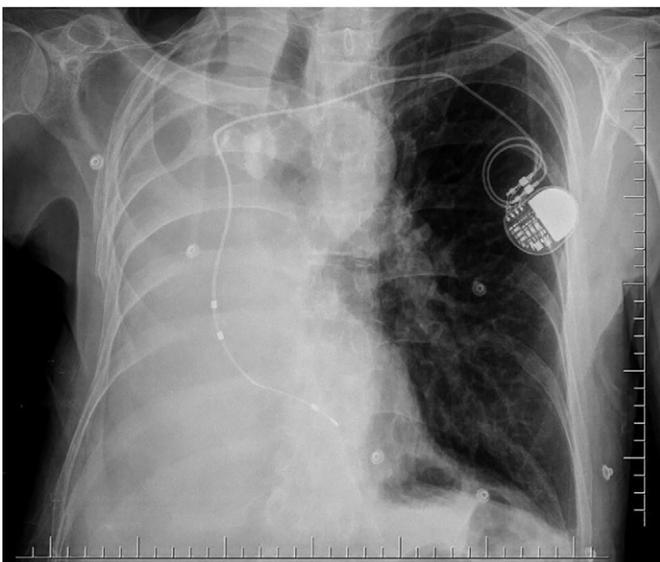
reduced the pulse amplitude to 3.0 V in order to reduce muscle stimulation. After that pectoral muscle stimulation finished instantly. However he was suffering again with twitching on pacemaker pocket in the same evening. The reasons of twitching on the pacemaker pockets were decreased impedance of ventricular lead and the unipolar polarity of the generator. We planned to replace of the ventricular lead. But he refused it because of the risks of complication and decreased lung capacity.

Fig. 2. Chest radiogram showing right pneumonectomy, single chamber permanent pacemaker with atrial sense part on the lead and the insulation defect around the subclavian region.
