International Journal of the Cardiovascular Academy

Short communication

Is pruritus over the pacemaker pocket may be a sign of a serious complication?

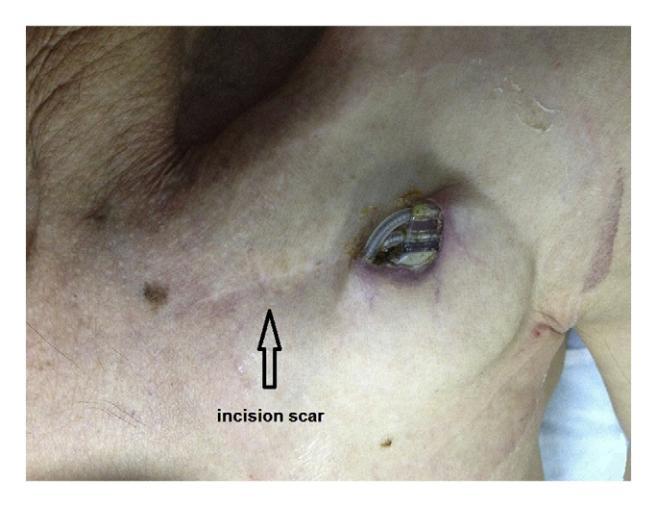
Figure. Migration and partial extrusion of pacemaker is seen in figure. Black arrow shows the incision scar of the pacemaker implantation.

A 73 year old male patient was admitted to the cardiology clinic with partial extrusion of pacemaker generator (Figure). A dual chamber rateadaptive pacemaker (DDDR) was implanted subcutaneously on the left pectoral side of the chest wall for total atrioventricular block one year ago by an experienced physician. Parenteral antibiotics were given to

Usually, pacemaker pocket infections cause extrusions of pacemaker generators. In our case, we thought that the migrated generator and scratching movements applied pressure to the skin and pressure dermatitis occurred. Pressure dermatitis and pacemaker pocket infection may have caused skin erosion and finally the generator extrusion. We assumed that the generator was contaminated, therefore we decided to remove the generator and pacemaker leads completely first and then implant a new DDDR pacemaker into the subcutis of the right chest wall. We removed the battery from the pocket and tried to extract the leads by traction to slowly break the lead free of its attachments but we have not succeeded. Because of this we used a lead extraction system (Liberator Beacon Tip Locking Stylet and Evolution Mechanical
